**4TH BRIGADE, 10TH INFANTRY DIVISION
IRAQI ARMY HEADQUARTERS BARRACKS
MISSAN PROVINCE, IRAQ**

SUSTAINMENT ASSESSMENT

**SIGIR PA-08-164
JULY 20, 2009**

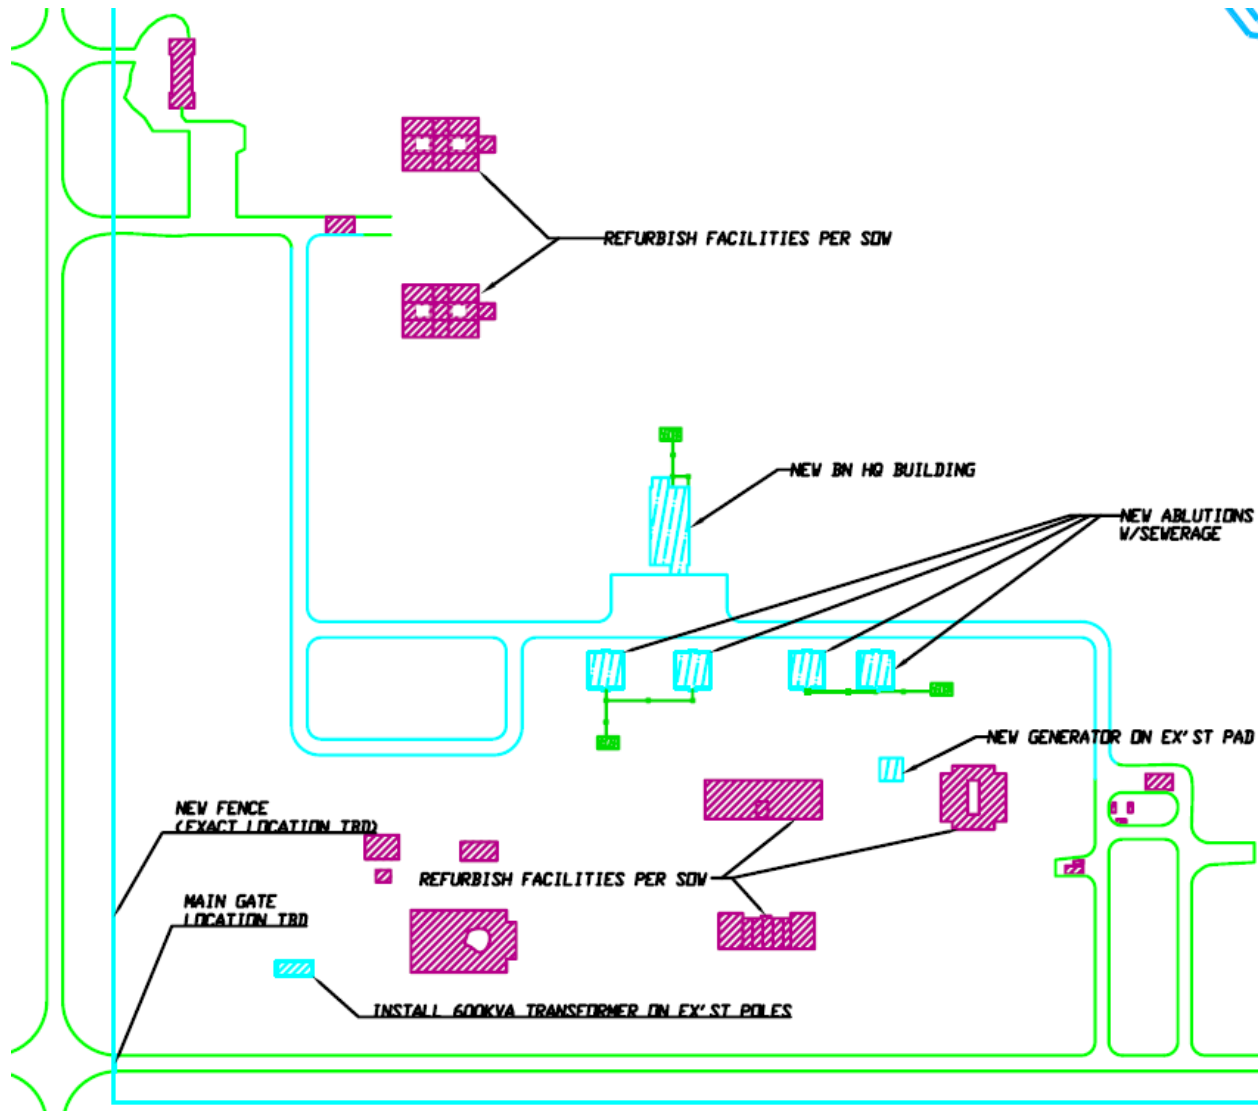
The project documentation provided by GRS did not include detailed construction drawings or design calculations for the project. SIGIR obtained and reviewed some Government Furnished Drawings (GFDs) provided to the contractor: the GFDs included a site location map (Figure 1), a rough site layout, general notes, septic tank details, and roadway cross-section details. A list of the GFDs provided to the contractor was included in the SOW.

The project documentation clearly identifies specific drawings that were to be supplied to the contractor for use during construction. The GFDs provided to SIGIR were determined to be adequate to outline the scope of the project for the contractor but were not adequate to construct the project. SIGIR requested additional contractor-furnished drawings from both GRD and GRS, but neither was able to locate the design drawings. The lack of available design drawings limited the ability of SIGIR to determine the adequacy of the project's design. However, the detailed list of specifications provided in the SOW did provide GRS with a limited basis for requiring the contractor to meet some minimum standards during the construction of this project.

Figure 1. Government Furnished Design C-001 site plan showing the existing and proposed buildings

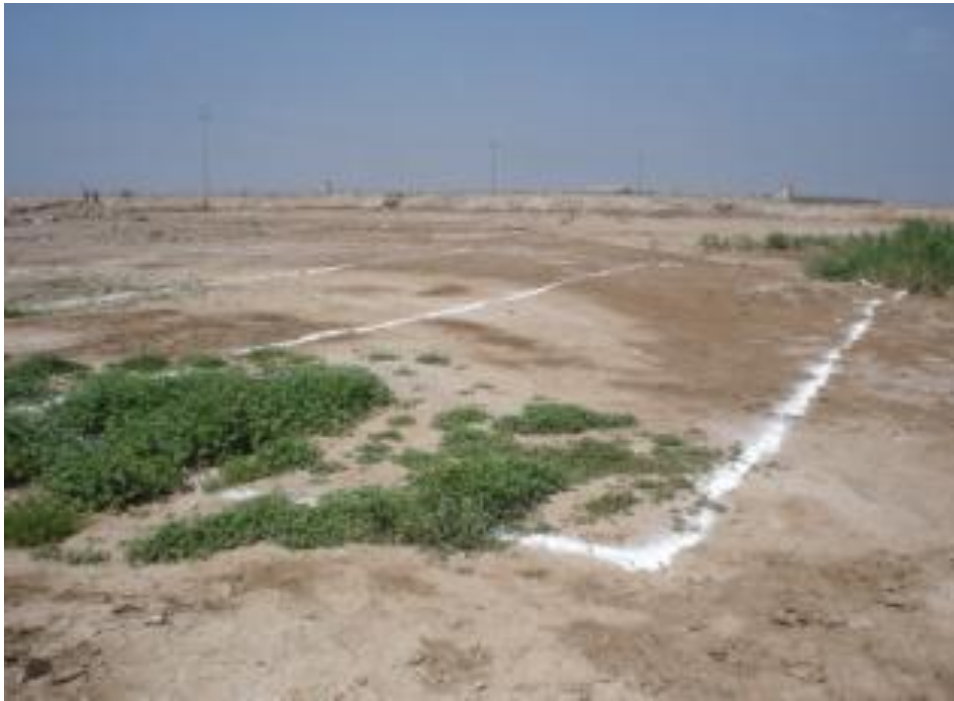
Before the contractor began new construction at the 4th Brigade 10th Infantry Division project, the contractor cleared the area and outlined the future locations of the buildings (Site Photo 1). Site Photo 2 shows the construction of two latrine buildings.

Site Photo 1. Future building location (Courtesy of GRS)

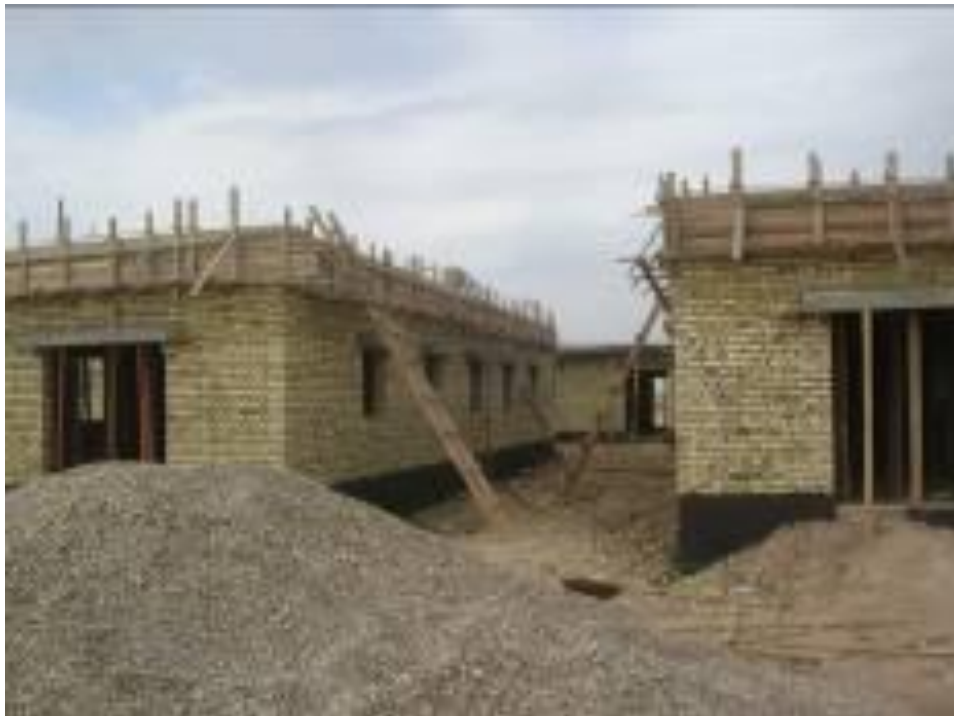
Site Photo 2. Latrine buildings (Courtesy of GRS)

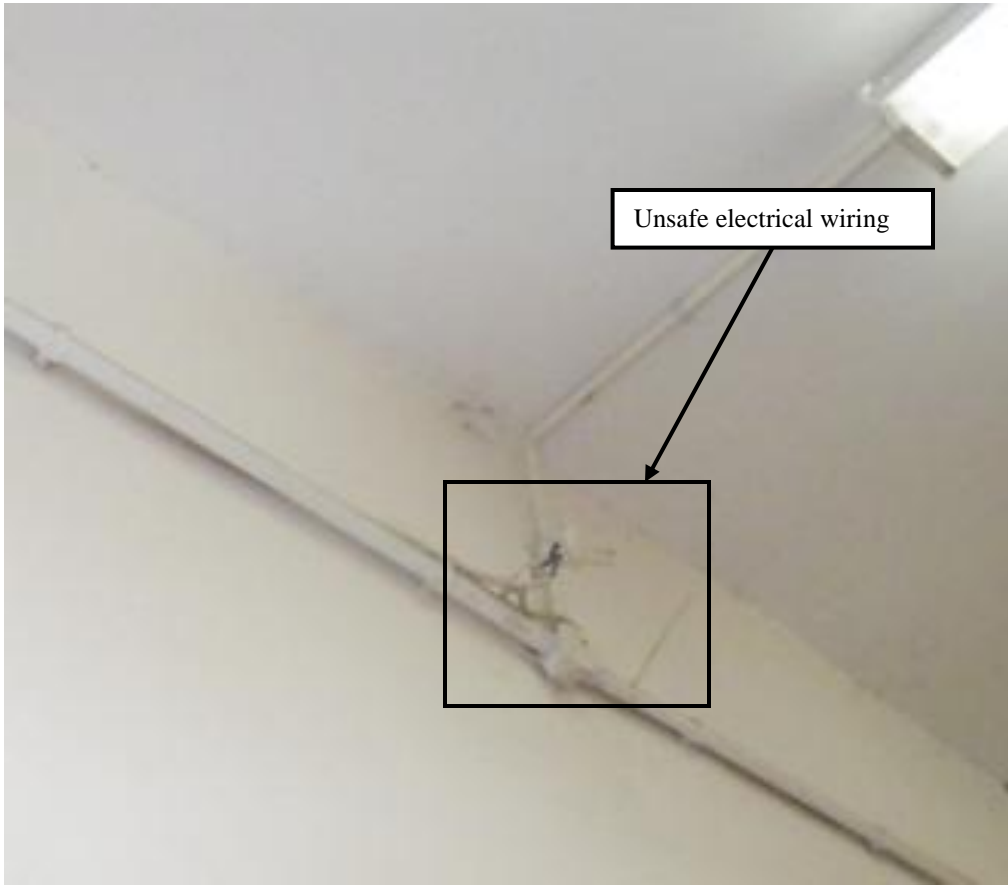
The building construction used typical Iraqi techniques for brick or block walls with a mortar/plaster/paint finish. The building exterior had areas of sandstone cladding (covering of one material with another) and areas of mortar/plaster/paint finish. The flooring was mostly terrazzo tile and a few offices were carpeted. The electrical system appeared to be well constructed, but had poor-quality fixtures. SIGIR noted unsafe electrical connections (Site Photo 3). The heating, ventilation, and air-conditioning system (HVAC) consisted of individual split units, which on-site personnel reported to be working. SIGIR found one room in which the tile flooring had significantly settled. This appeared to be the only major defect in the building. The remainder of the building appeared to be well maintained; however, wall tiles behind the stove and preparation tables in the battalion headquarters kitchen area were missing (Site Photo 4).

Site Photo 3. Unsafe electrical wiring

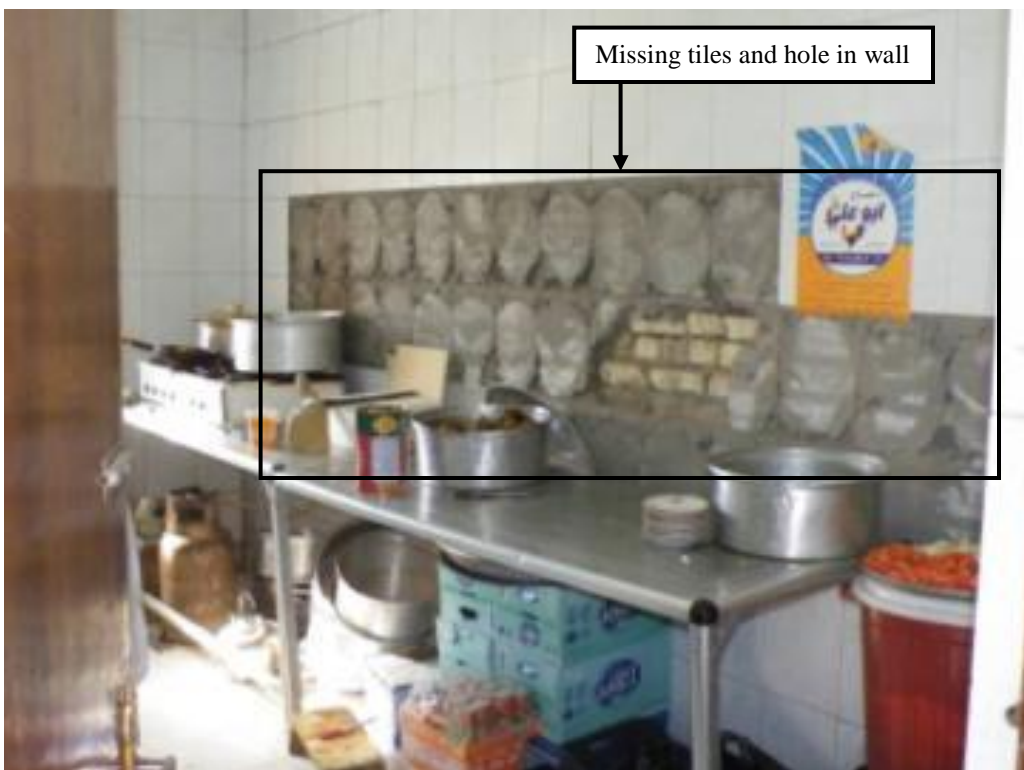
Site Photo 4. Damaged kitchen wall and tiles

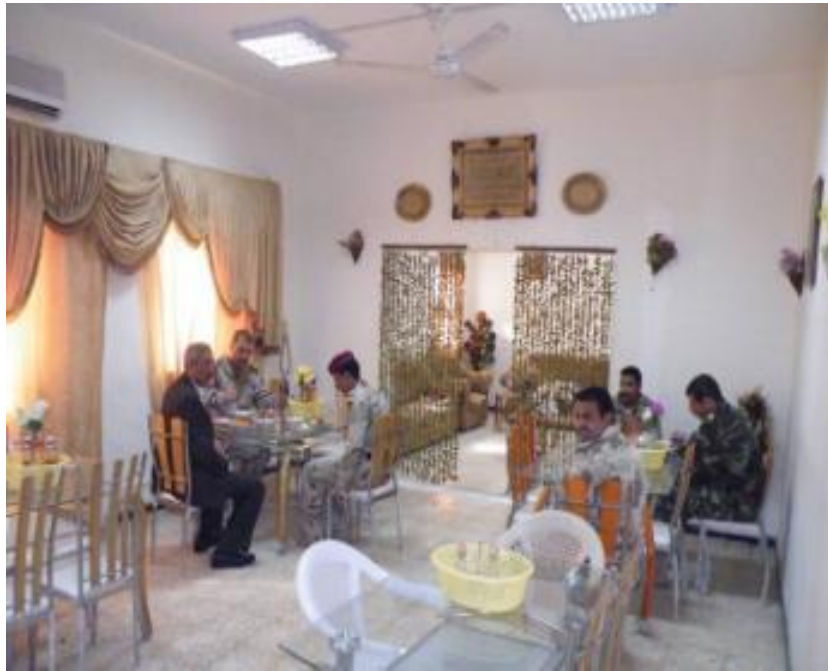
Because the contract did not provide for furnishings, GRS personnel were not sure if the furnishings were transferred from another facility or purchased by the Government of Iraq. The commander's office and the dining area furnishings appeared functional, but not very durable (Site Photo 5).

Site Photo 5. Commander's dining area

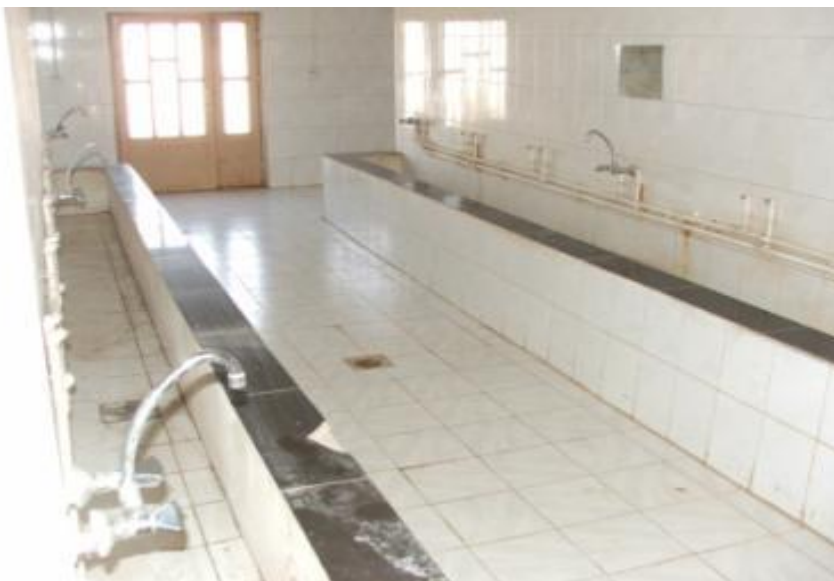
The SOW stated that the contractor was to construct four 12 x 12.4 m latrine buildings. The facilities would contain 20 water closets, 20 showers, and 28 faucets for hand washing. Site Photo 6 shows the hand-washing area. The restrooms were functional; however, SIGIR observed cracks in the tile, missing and broken faucets, and a lack of housekeeping evident by the level of cleanliness observed.

Site Photo 6. Hand-washing station

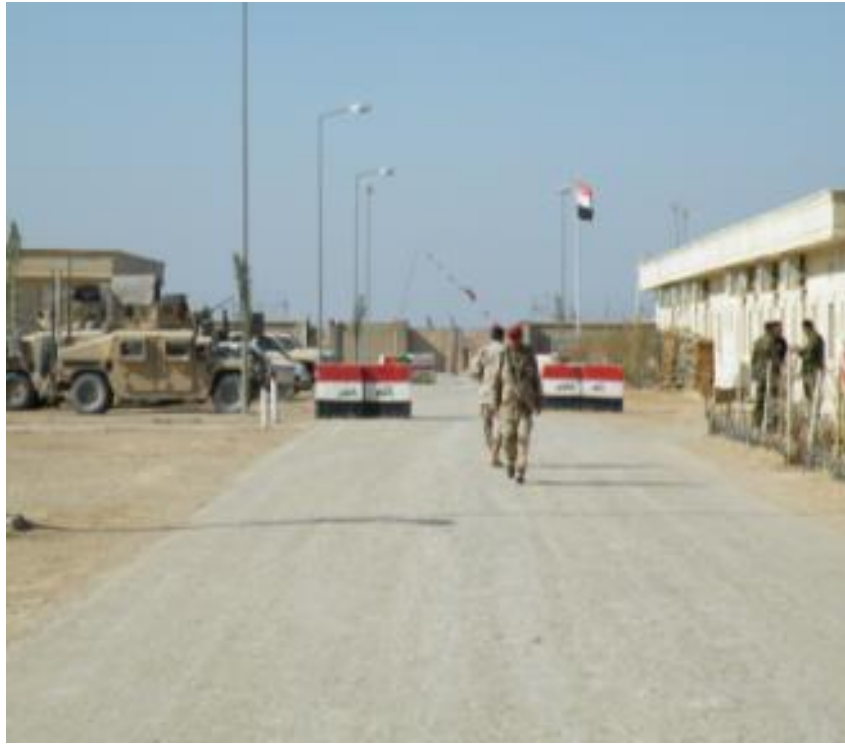
The contractor was required to construct a 7 m-wide aggregate roadway to connect the new construction with the existing roads. SIGIR observed that the project had paved roadways between the buildings connecting to the main entrance (Site Photo 7). Also, the security lights were to be mounted on 4 m-high poles. During the site visit, SIGIR observed mounted security lights around the perimeter wall.

Site Photo 7. Paved road

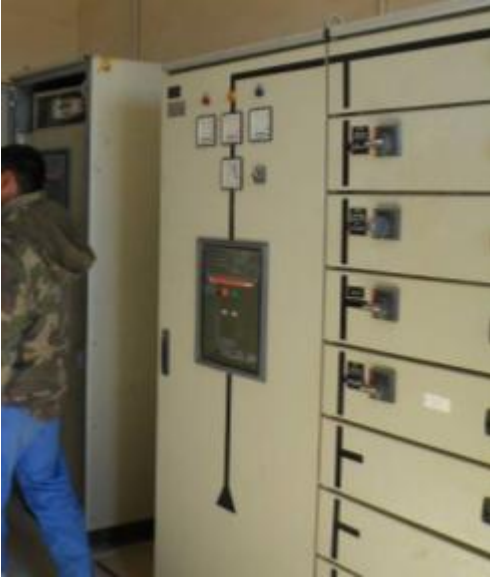
During the site assessment, SIGIR observed the electrical building, which contained several control panels and an automatic transfer switch (Site Photo 8). Two generators were in a separate covered shed that was secured with chain-link fencing (Site Photo 9). On-site personnel stated that the electrical grid was used and the automatic transfer switch was working properly. At the time of the site assessment, the generators were not operating. The generators appeared to have new filters, but the exterior was covered with excessive dust. SIGIR could not verify that any maintenance had been performed on the generators; however, on-site personnel stated that the generators were operational.

Site Photo 8. Electrical control panels

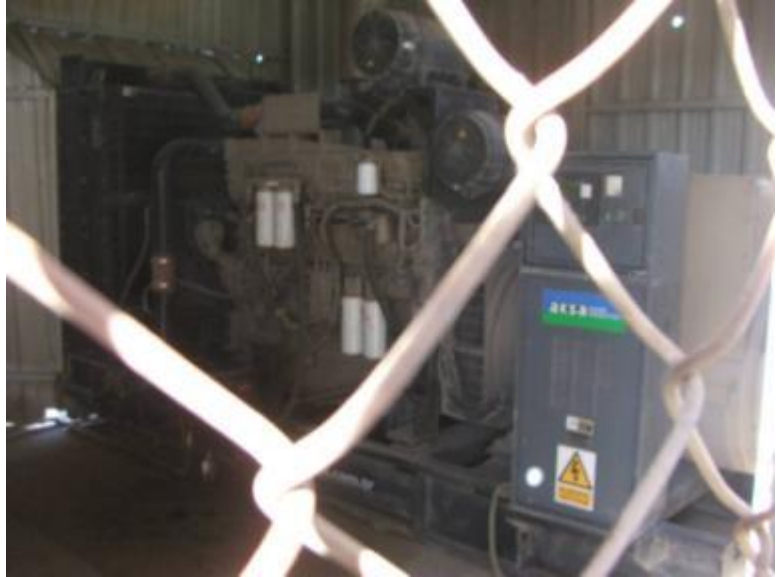
Site Photo 9. Generators

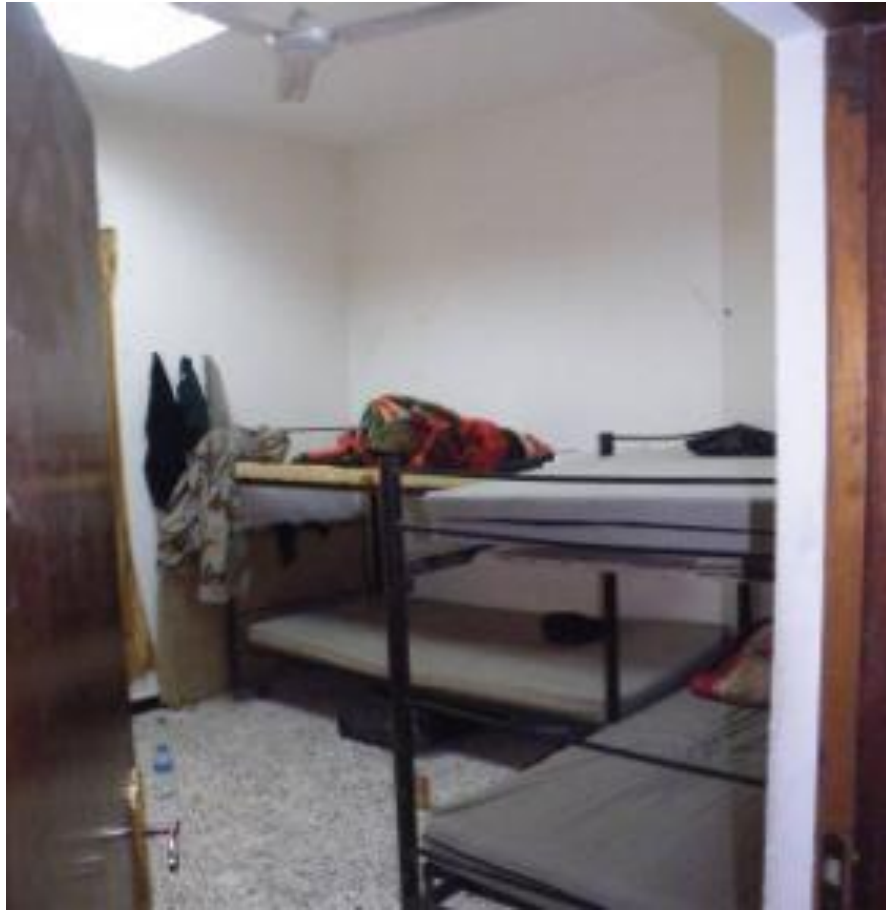
The barracks and office buildings included multiple buildings with sleeping, hand-washing, or storage areas. Barracks building construction used typical Iraqi techniques for brick/block walls with mortar/plaster/paint or tile finish. Also, the exterior consists of areas with sandstone cladding and mortar/plaster/paint finish. The barracks and office buildings had terrazzo tile flooring, and the ceiling was painted concrete with fluorescent lighting. The electrical systems appeared to be well constructed, but poor-quality fixtures were used. The HVAC system consisted of individual split units, which on-site Iraqi personnel stated were working. The sleeping rooms consisted of metal bunks or simple floor mats (Site Photo 10). The faucet fixture quality was poor, and some of the faucets were removed. One of the storage areas was converted into a convenience store to serve the soldiers (Site Photo 11).

Site Photo 10. Sleeping room

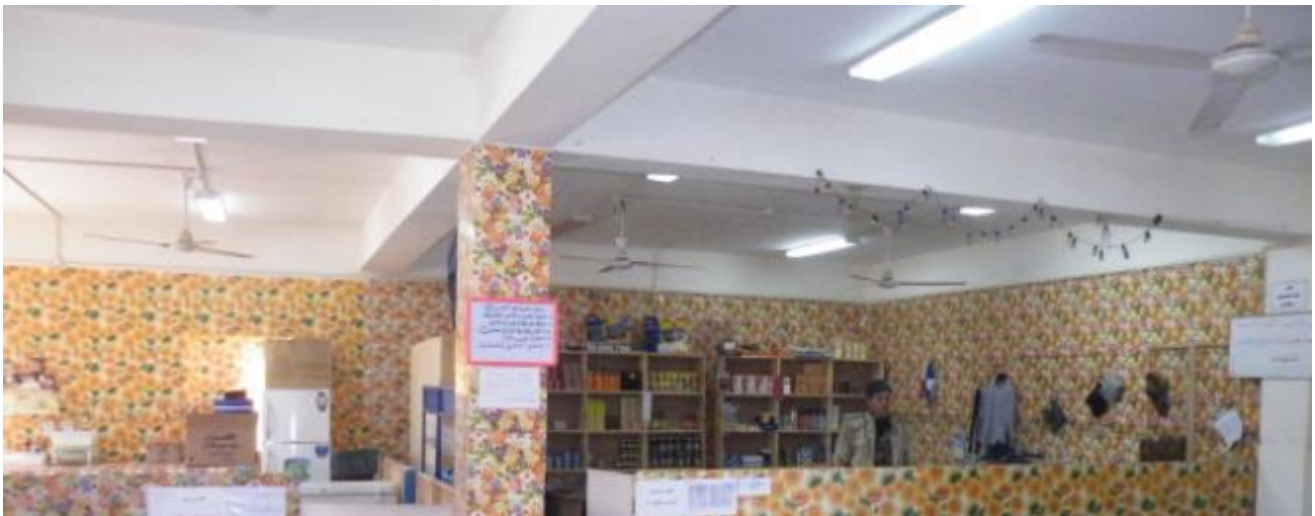
Site Photo 11. Room converted into convenience store

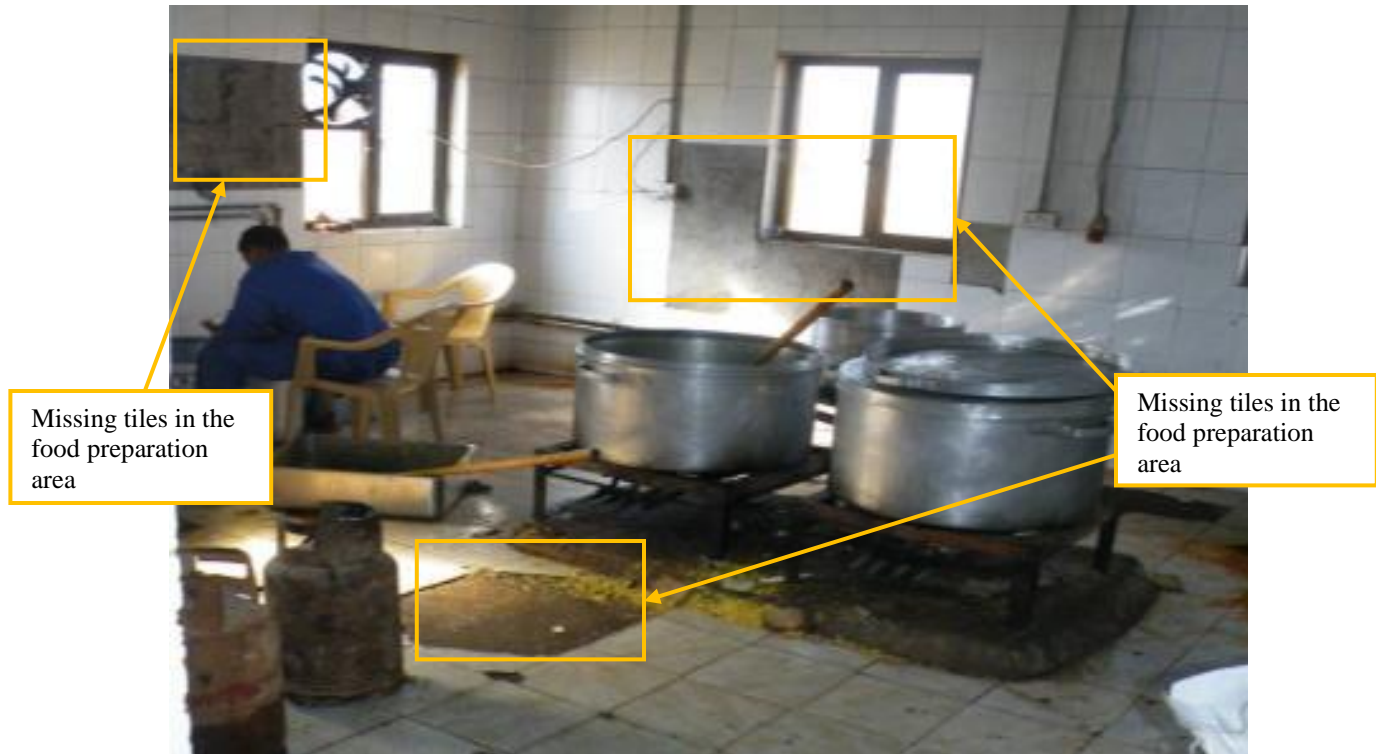
A separate building was used for preparing and cooking the food. This building was similar in construction, but was not well maintained. For example, wall and floor tiles were missing or damaged, and food, dirt, and debris covered the floor and walls (Site Photo 12). Although the food preparation area was designed for electrical food preparation and heating equipment, no electrical equipment was present. Instead, meals were cooked using portable gas cylinders with open-flame grates. The building appeared adequately constructed.

Site Photo 12. Food preparation and cooking area

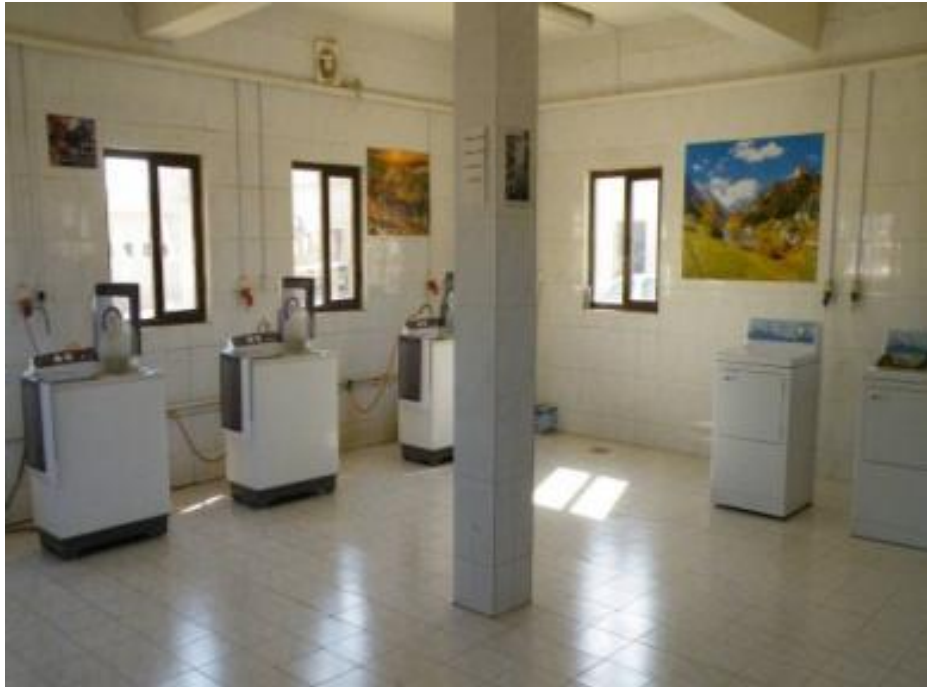
The laundry facility was constructed using the typical brick/block construction with mortar/plaster exterior. The interior was finished with large wall and floor tiles (Site Photo 13). SIGIR found the laundry facility to be well-maintained and in operation at the time of the assessment. The laundry facility was equipped with several washers and dryers, with several electrical and plumbing hookups for additional machines. The electrical and HVAC systems appeared adequately installed and operational.

Site Photo 13. Laundry facility interior

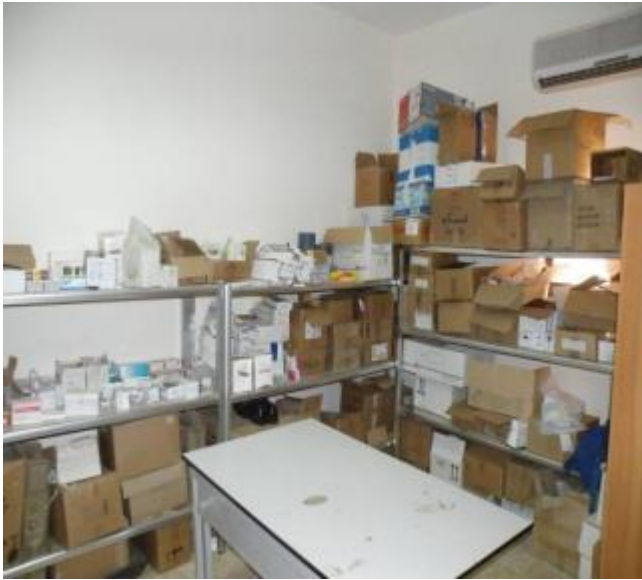
The medical building was constructed using bricks/blocks with mortar/plaster finish. The construction and maintenance of the building was adequate. The interior consisted of a few rooms and was clean but not sterile. At the time of the site visit, no one was being treated; however, medical supplies were readily available (Site Photo 14). SIGIR determined that the medical building was equipped to provide minor medical care to personnel, including dispensing medical supplies, preventing infectious disease, and disbursing pharmaceuticals. SIGIR observed an Iraqi medical technician on site and available.

Site Photo 14. Interior medical room with supplies

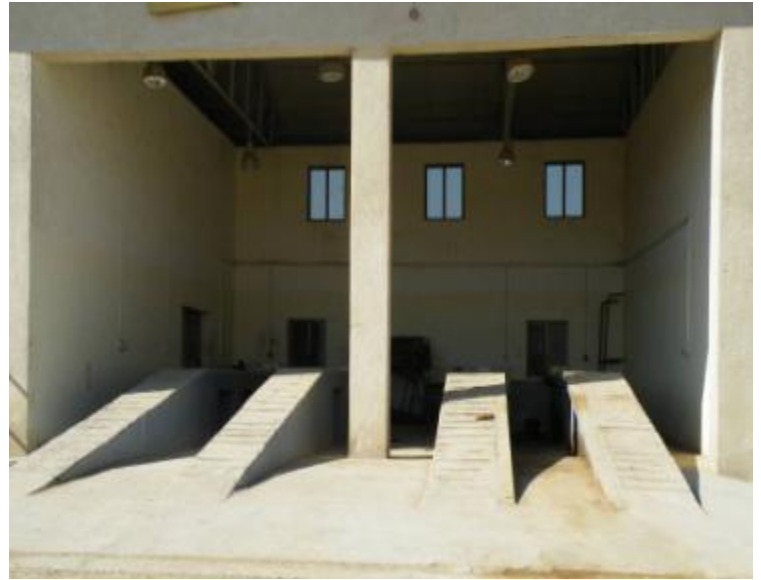
At the time of the assessment, vehicles were not being serviced (Site Photo 15). However, on-site personnel stated that the maintenance building was functioning, and SIGIR observed that the building was adequately maintained.

Site Photo 15. Equipment maintenance building
